REPORT: FE-43-97

RAILROAD: Union Pacific Railroad Company (UP)

LOCATION: Topeka, Kansas

DATE, TIME: Dec. 11, 1997, 5:05 a.m., CST

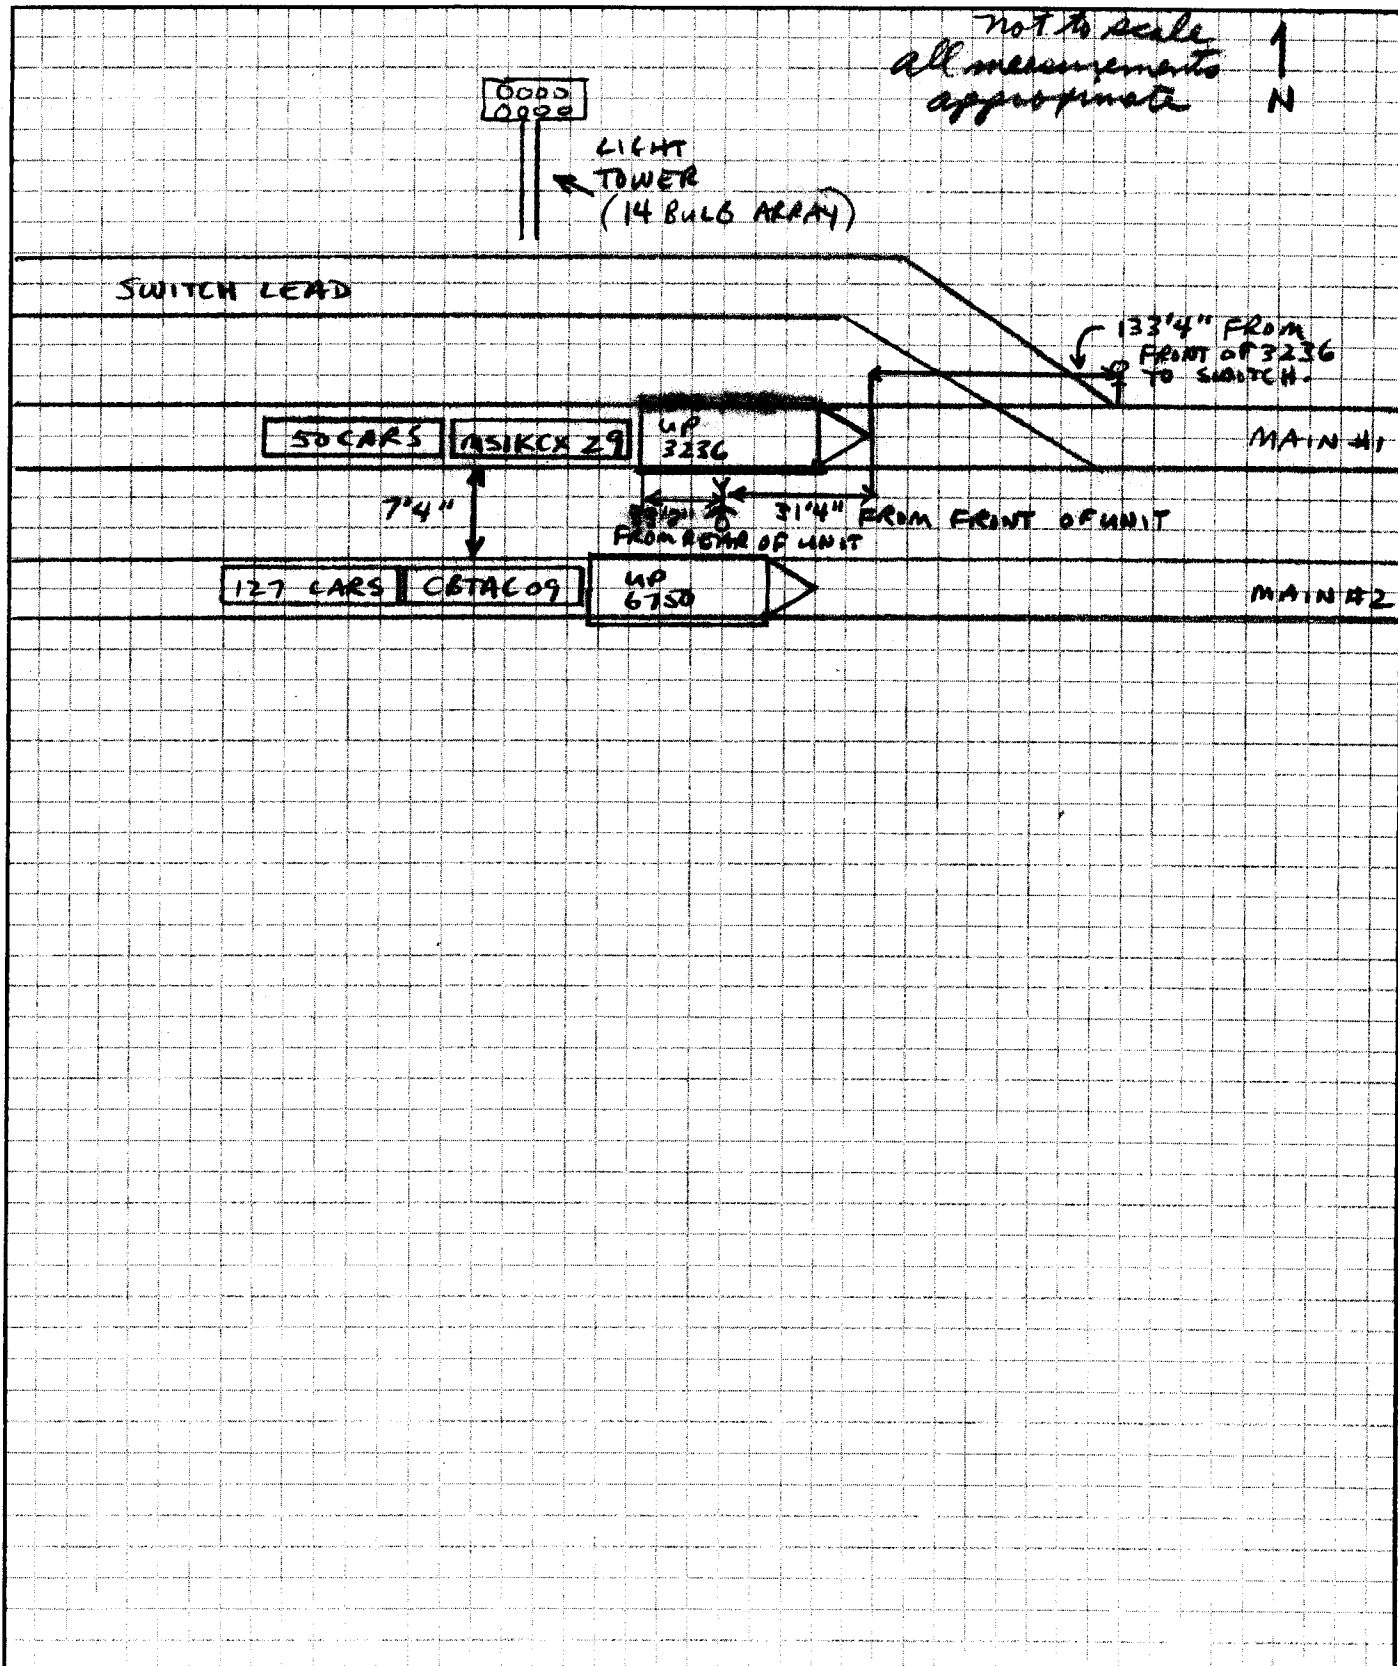
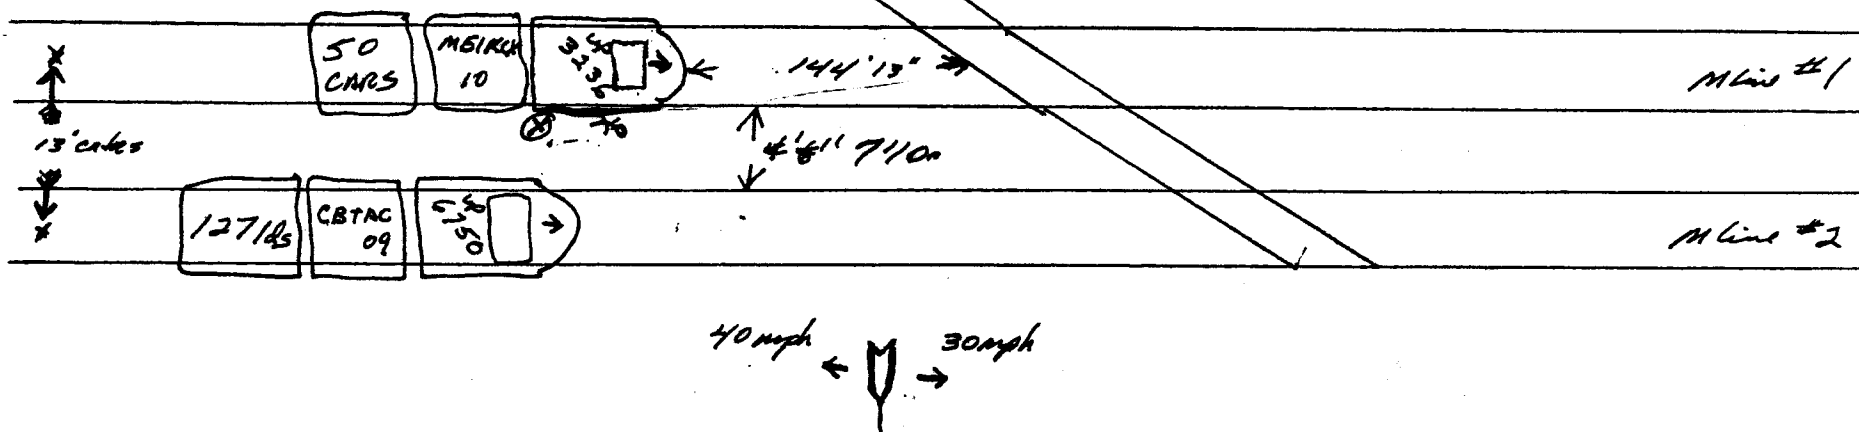
FORM 52072 (Rev. 3-94)
ACCIDENT DIAGRAM

The Locomotive Engineer failed to observe the oncoming train on the adjacent track and was struck after dismounting his locomotive.

⊙ Point of impact

MSIRCK-10 - STOPPED E-BND

CBTAC-09 31 mph E-BND
